Subject: Cylinder testing

-Sam Walder
University of Bristol Underwater Club Equipment Officer

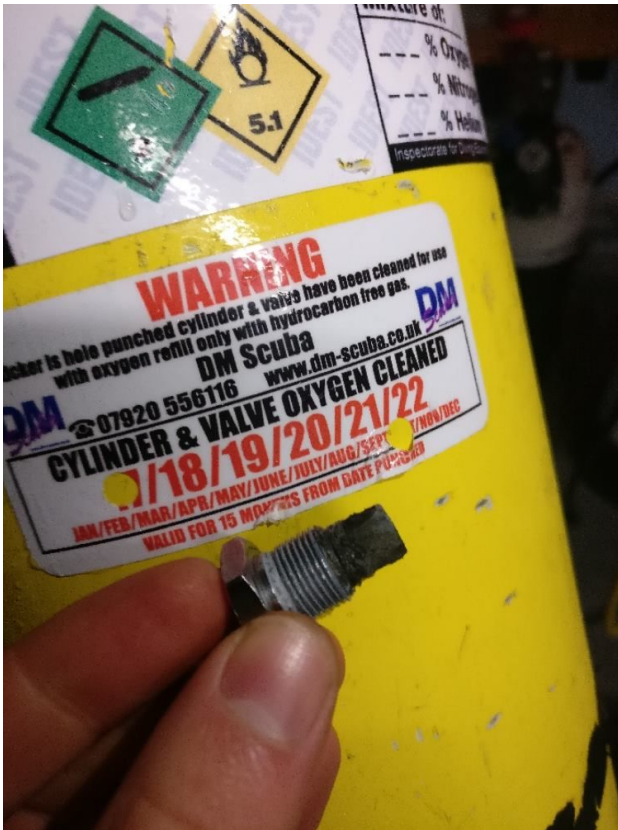
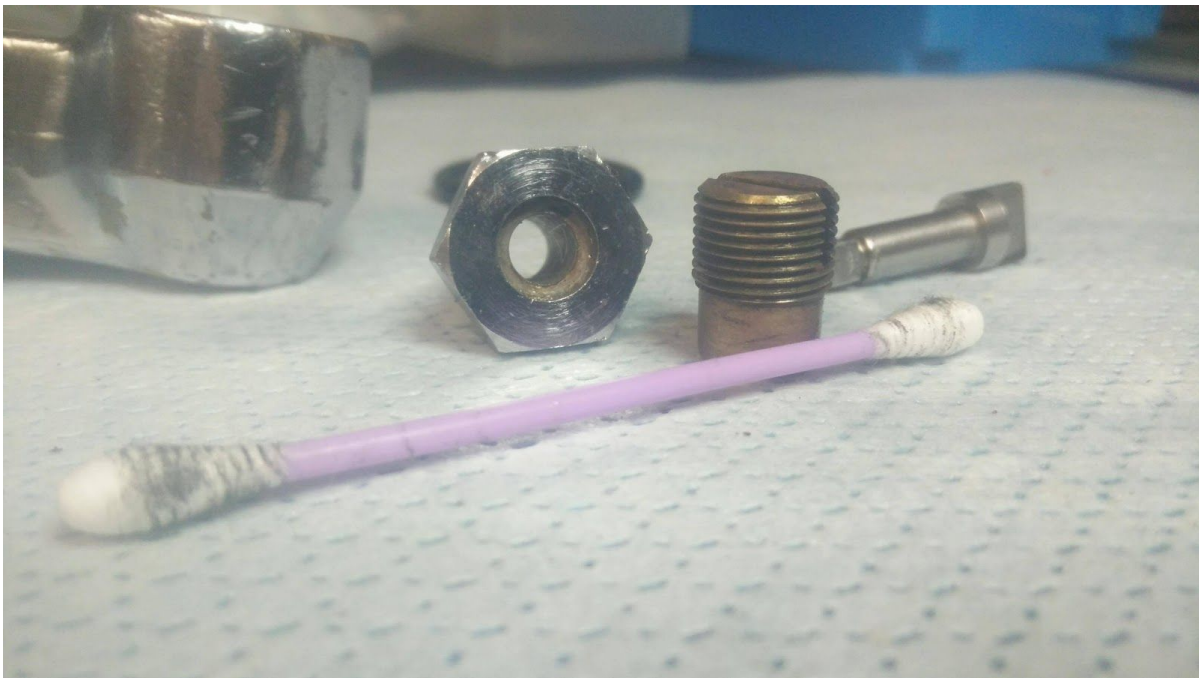
With regards to the O2 clean cylinders that we have had from you, one of our members hoping to partial pressure blend a nitrox mix decided to check the valves of all of the O2 clean cylinders before using them. He did this as a TDI trained O2 service technician because he had found one of the cracked bonnet nuts when we were troubleshooting some issues. Below is a photo of the inside of one of the cylinder valves (note this is before it had been used for any diving).

He was somewhat baffled by whatever the black stuff is on all of the valve components as only a thin smear of crytox or similar was expected.

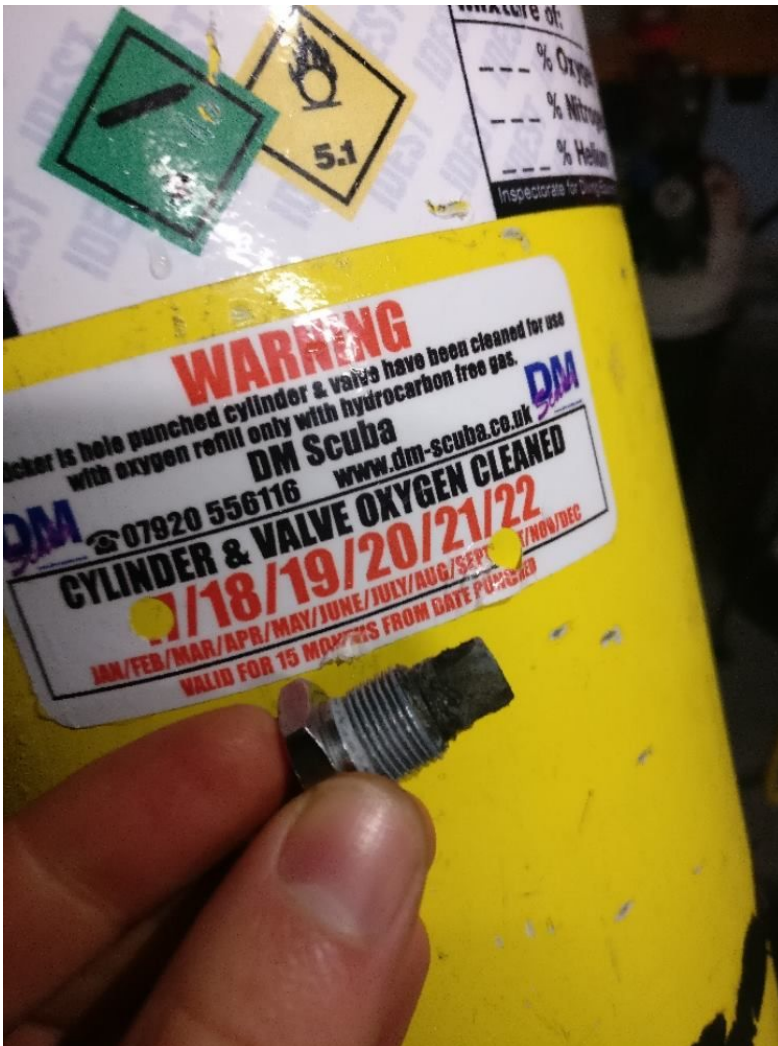
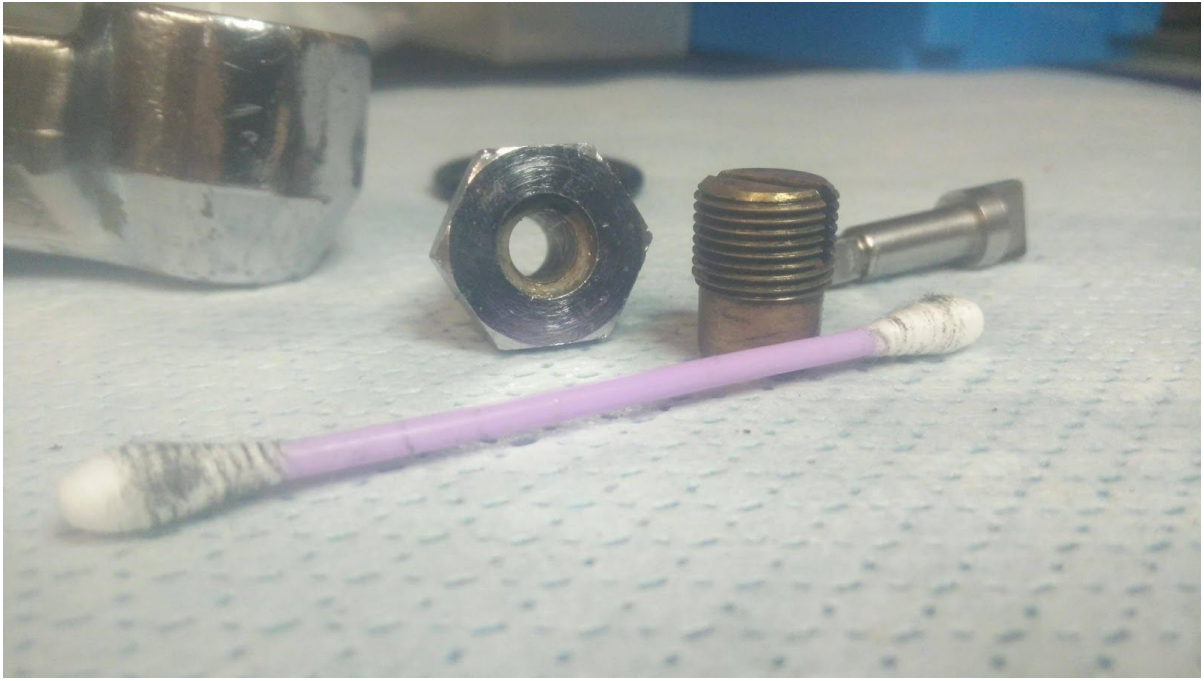
Photos of valves

A common issue we seem to be finding is that the bonnet nut that holds the spindle in the valve has been over tightened, and on several this has cracked the nut rendering it useless. I have kept an example of this to show to people. This is an odd issue as the torque on this nut should not be all that much, the seal is made via a barrel seal with an O ring. I have found that replacing the O ring often fixes leaking ones and in several other cases the O ring has just been absent from the assembly altogether.
