# Report on Compressor Failure

Sam Walder - Equipment Officer 2017/18

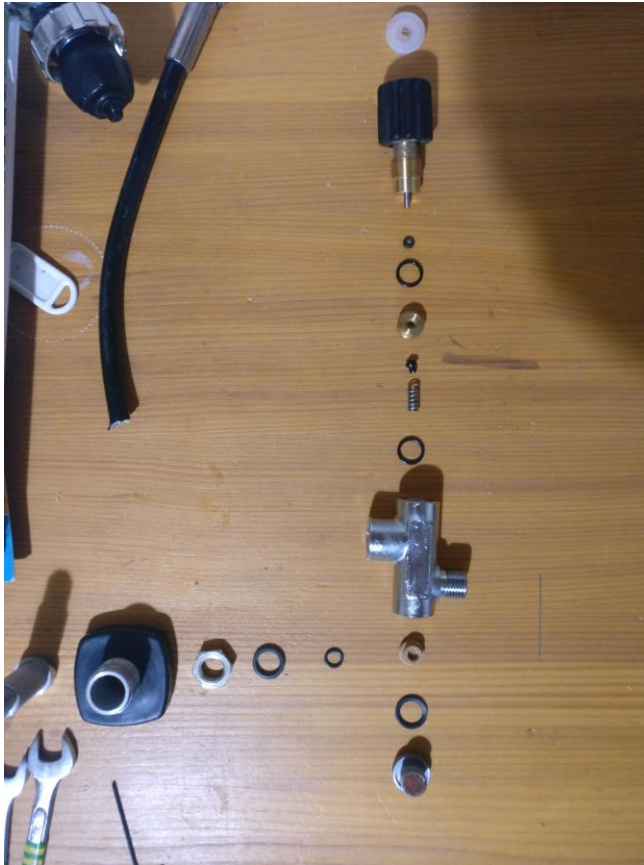
Figure 1 - Disassembled cylinder filling valve

- The pipework and manifolds were disassembled and taken to Bristol Channel Diving Services to be cleaned. The disassembly is surprisingly easy to perform.
- The filling whips were a concern as we were initially unsure whether the oil would have damaged one. Appendix 2 contains the emails with BCD that establish that this is not the case. The whips were cleaned by Bristol Channel Diving Services.
- The filling valves were stripped down, cleaned and serviced with help from Bristol Channel Diving Services

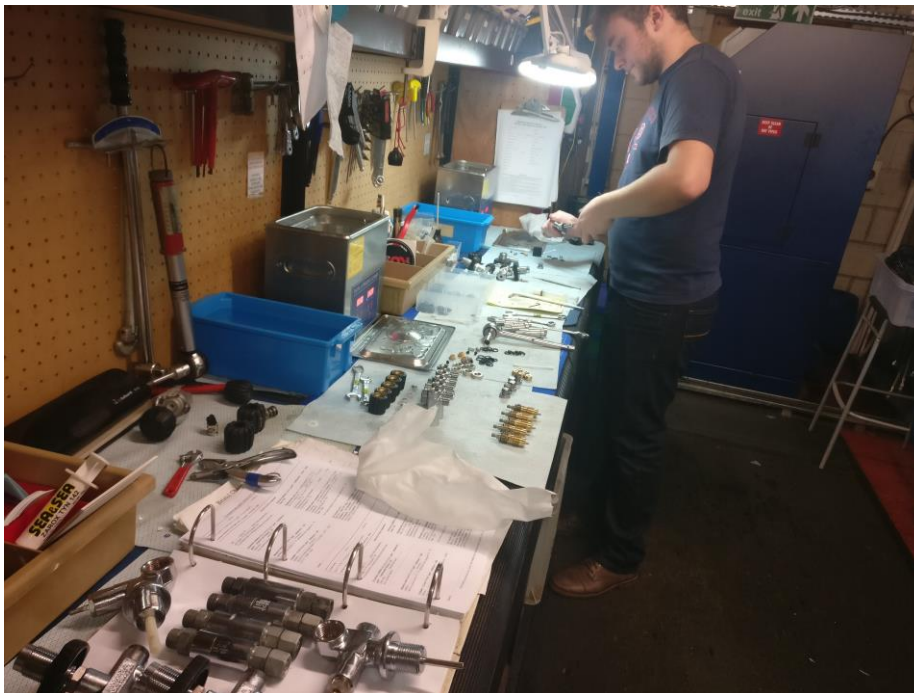
Figure 2 - Greg helping the service the filling valves at Bristol Channel Diving Services

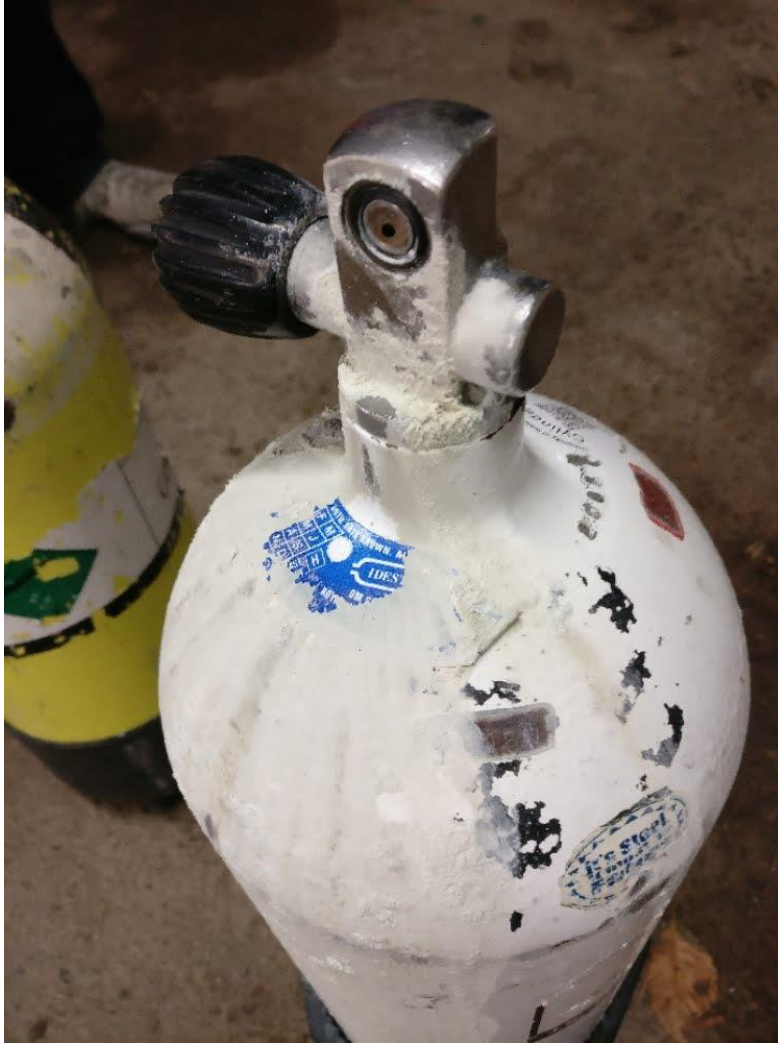
Some time during pumping, an O ring in one of the filling whips had blown out. This meant that the compressor did not reach final pressure and was not shut down. In total it ran for around 85 hours, not far off our typical annual usage.

*Figure 3 - The cylinder on which the O-ring failed. Note that it was in the DIN to A-clamp adaptor that the O-ring failed*

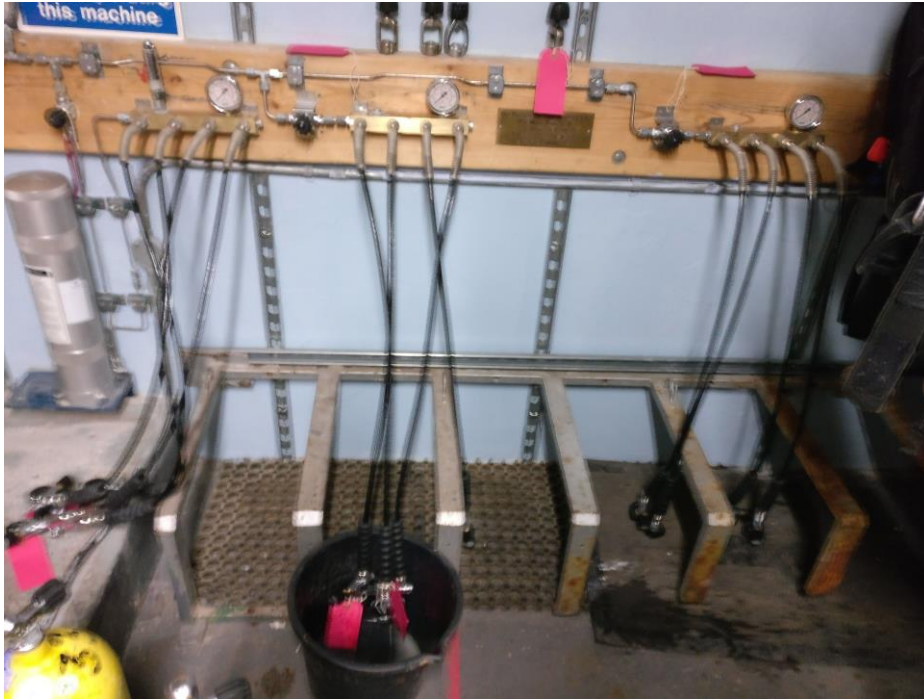
Figure 4 - the state of the filling station after removing the parts

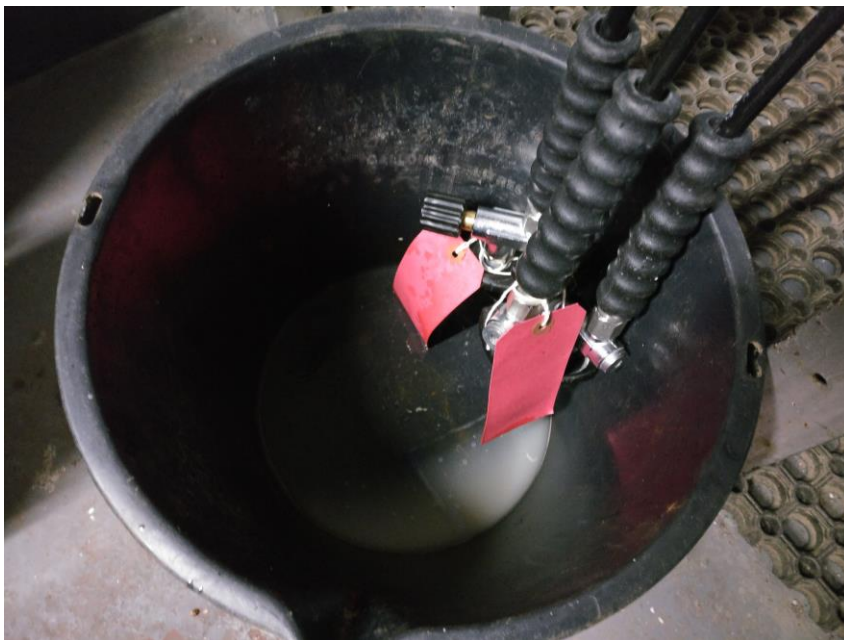
Having run for so long continuously, the filter had become saturated and water and oil from the compressor entered the pipework, manifolds, filling whips and cylinders.

Figure 5 - A bucket catching the drips from the filling whips

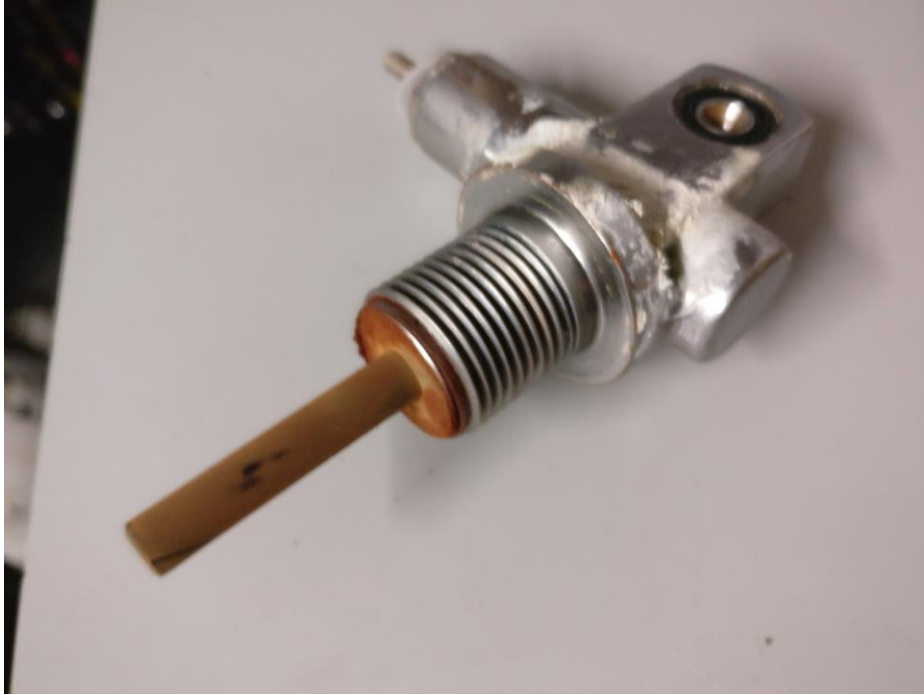
*Figure 6 - The inside of the valve from the cylinder on which the issue occurred*

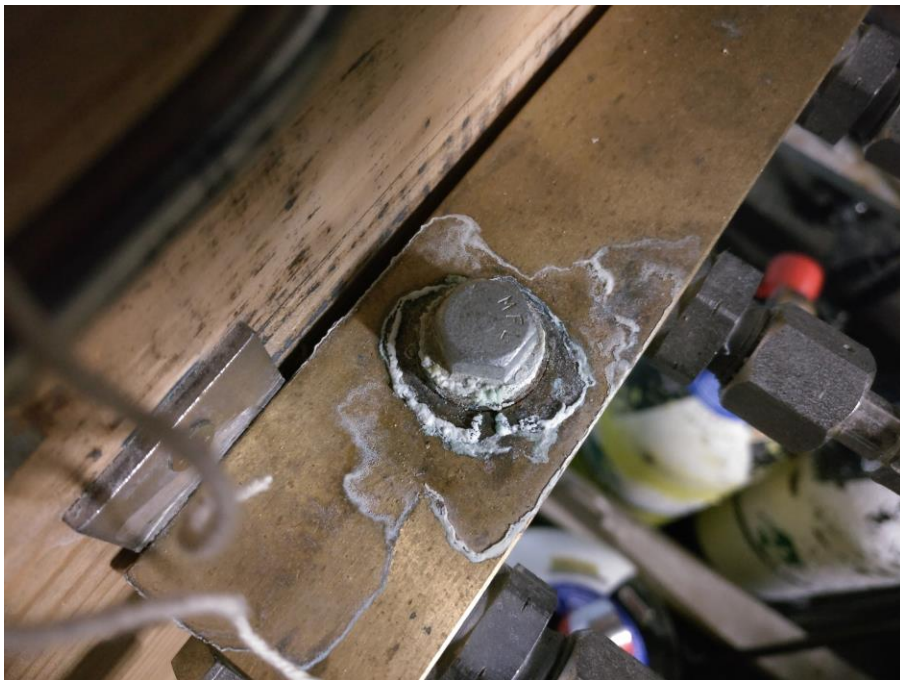
OK I think the corrosive nature of the fluid has eaten the rubber centre of the Dowty washer on the four hose block, and that is good and bad news.

It does appear however to have had an effect on the rubber in the seal, hence the leak and stain. The hard plumbing is in sections with compression joints connecting each piece up, that means it can be split down and put in a car for cleaning 🖐.

With regards to the 'corrosion' on the block, a closer inspection I believe shows some more good news. What I has thought was corrosion did not match with what any of our materials people, and a closer look shows it not to be. It is actually where oil and water has come through a very small leak (which over 3 days did not seem all that small) and has then dried out. This tallies with the deposit left all over the cylinder that had the blown out O-Ring. Photos of all of this attached.

*Figure 7 - Residue surrounding a leak on one of the manifolds*

The hard plumbing, valves, and other metal fittings can all be cleaned.

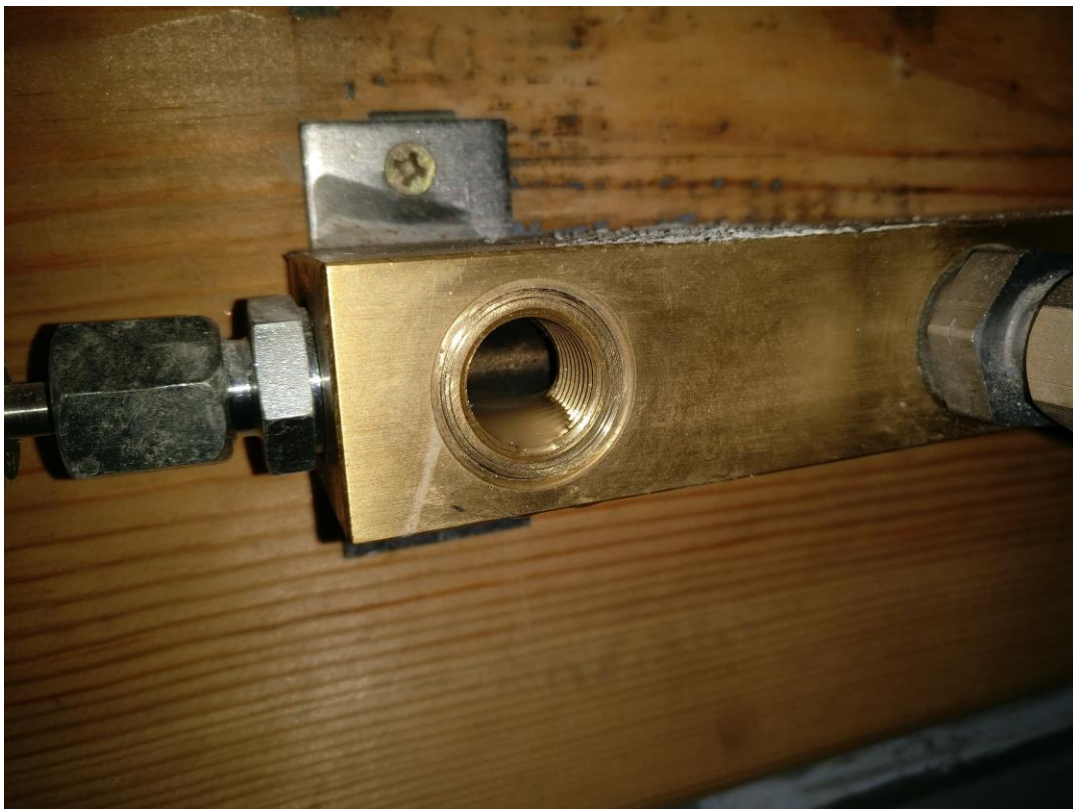
*Figure 9 - Photo showing the water in the manifold blocks*
