# Report on Compressor Failure

Sam Walder - Equipment Officer 2017/18

## Outline

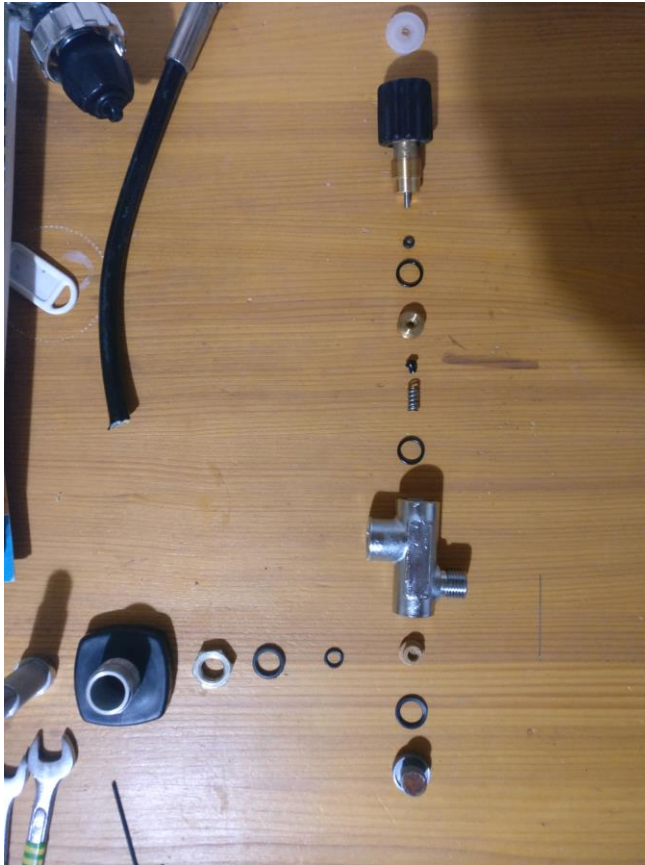
Figure 1 - Disassembled cylinder filling valve

- The pipework and manifolds were disassembled and taken to Bristol Channel Diving Services to be cleaned. The disassembly is surprisingly easy to perform.
- The filling whips were a concern as we were initially unsure whether the oil would have damaged one. Appendix 2 contains the emails with BCD that establish that this is not the case. The whips were cleaned by Bristol Channel Diving Services.
- The filling valves were stripped down, cleaned and serviced with help from Bristol Channel Diving Services

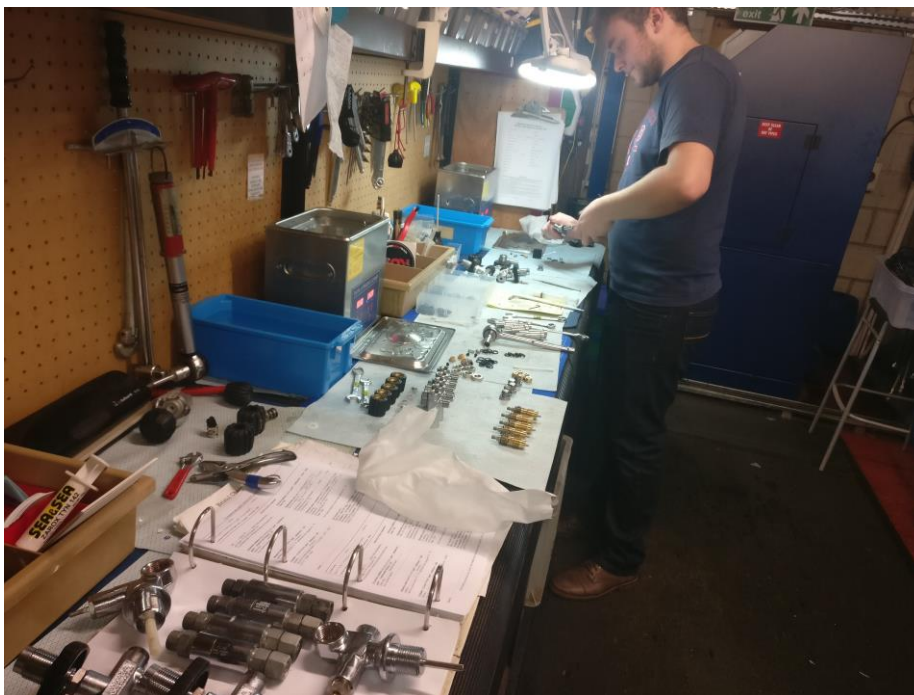
*Figure 2 - Greg helping the service the filling valves at Bristol Channel Diving Services*

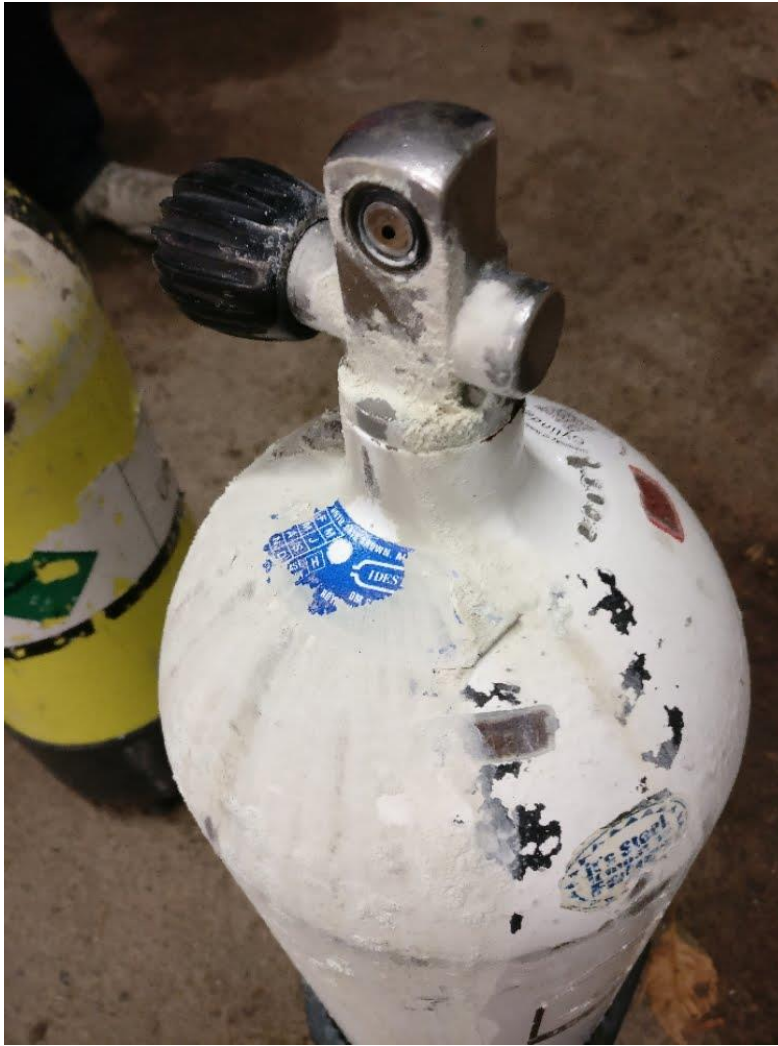
Some time during pumping, an O ring in one of the filling whips had blown out. This meant that the compressor did not reach final pressure and was not shut down. In total it ran for around 85 hours, not far off our typical annual usage.

*Figure 3 - The cylinder on which the O-ring failed. Note that it was in the DIN to A-clamp adaptor that the O-ring failed*

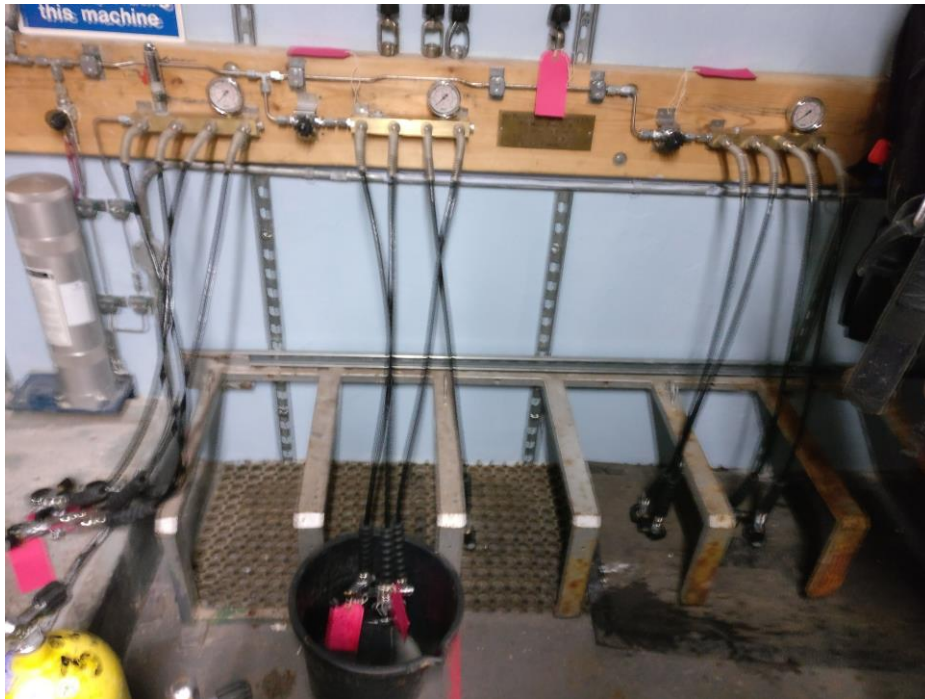
Figure 4 - the state of the filling station after removing the parts

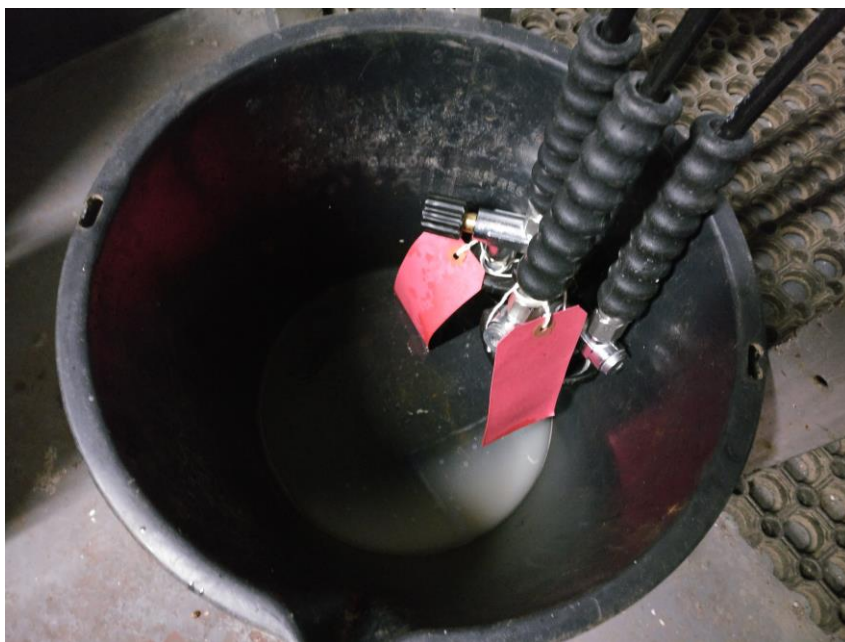
Figure 5 - A bucket catching the drips from the filling whips

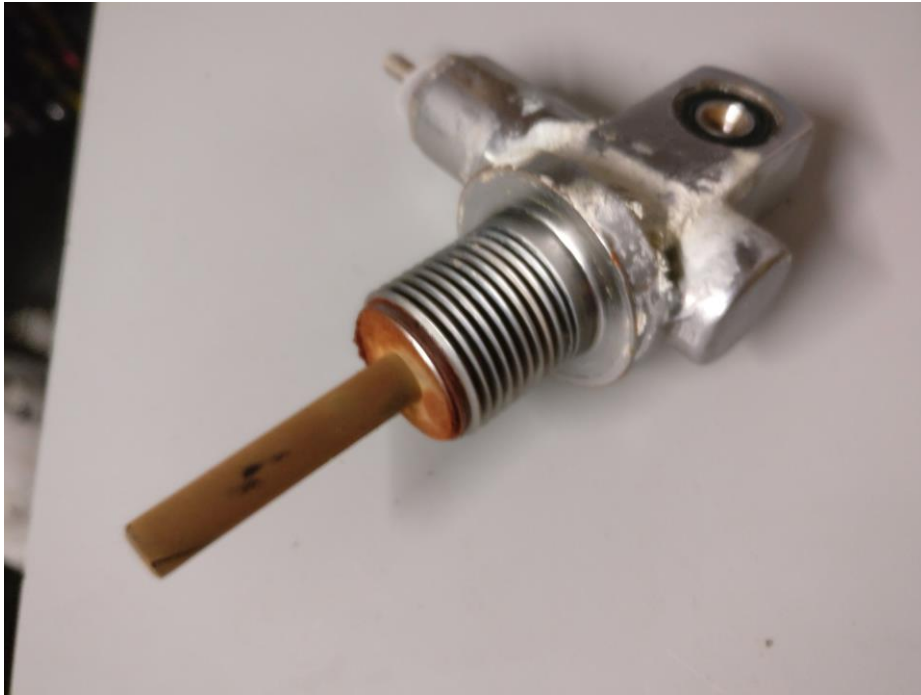
*Figure 6 - The inside of the valve from the cylinder on which the issue occurred*

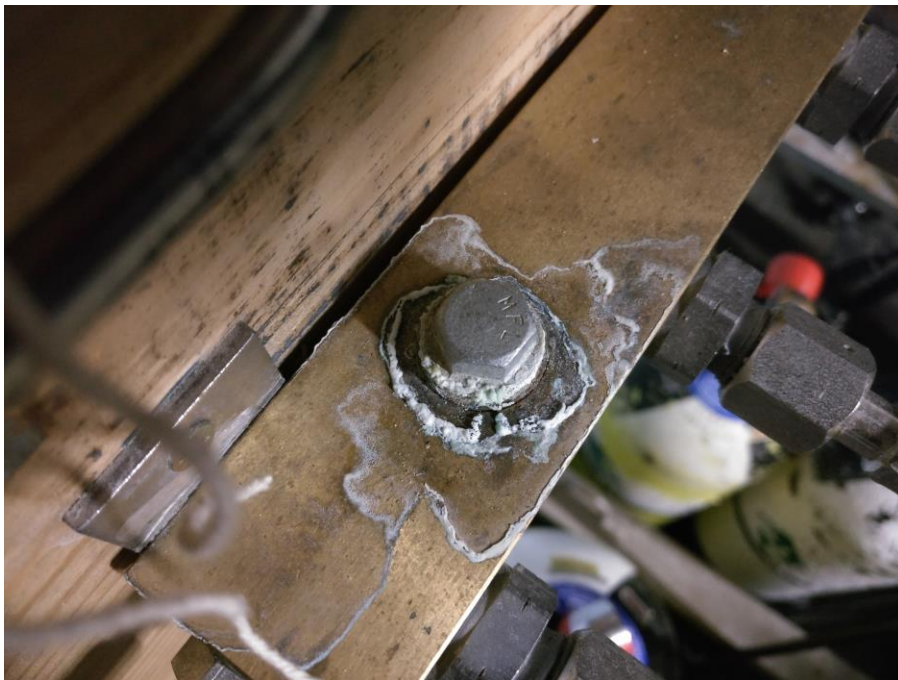
OK I think the corrosive nature of the fluid has eaten the rubber centre of the Dowty washer on the four hose block, and that is good and bad news.

With regards to the 'corrosion' on the block, a closer inspection I believe shows some more good news. What I has thought was corrosion did not match with what any of our materials people, and a closer look shows it not to be. It is actually where oil and water has come through a very small leak (which over 3 days did not seem all that small) and has then dried out. This tallies with the deposit left all over the cylinder that had the blown out O-Ring. Photos of all of this attached.

*Figure 7 - Residue surrounding a leak on one of the manifolds*

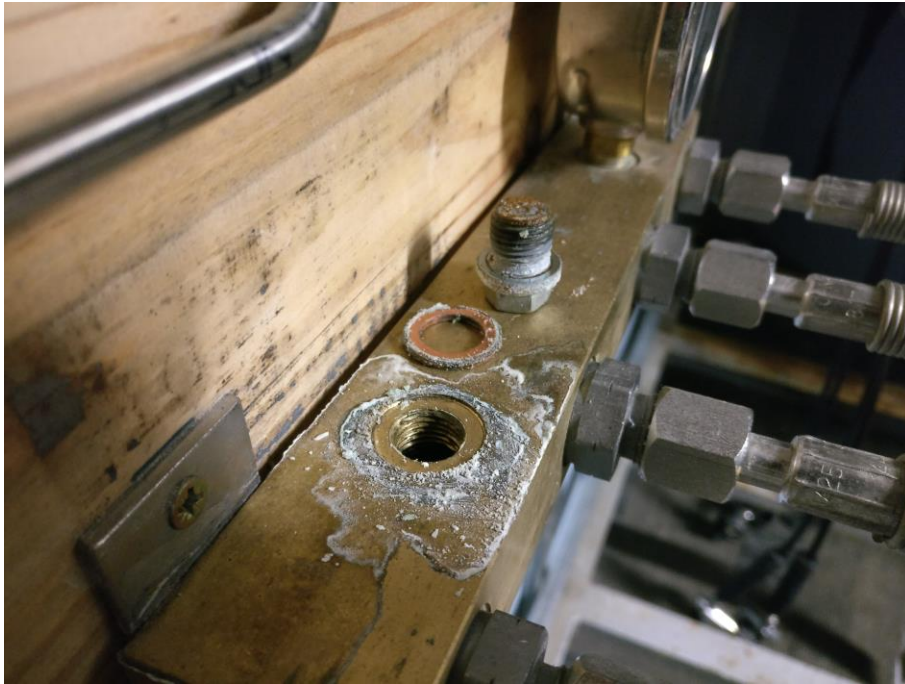
Figure 8 - another shoot of the oil residue

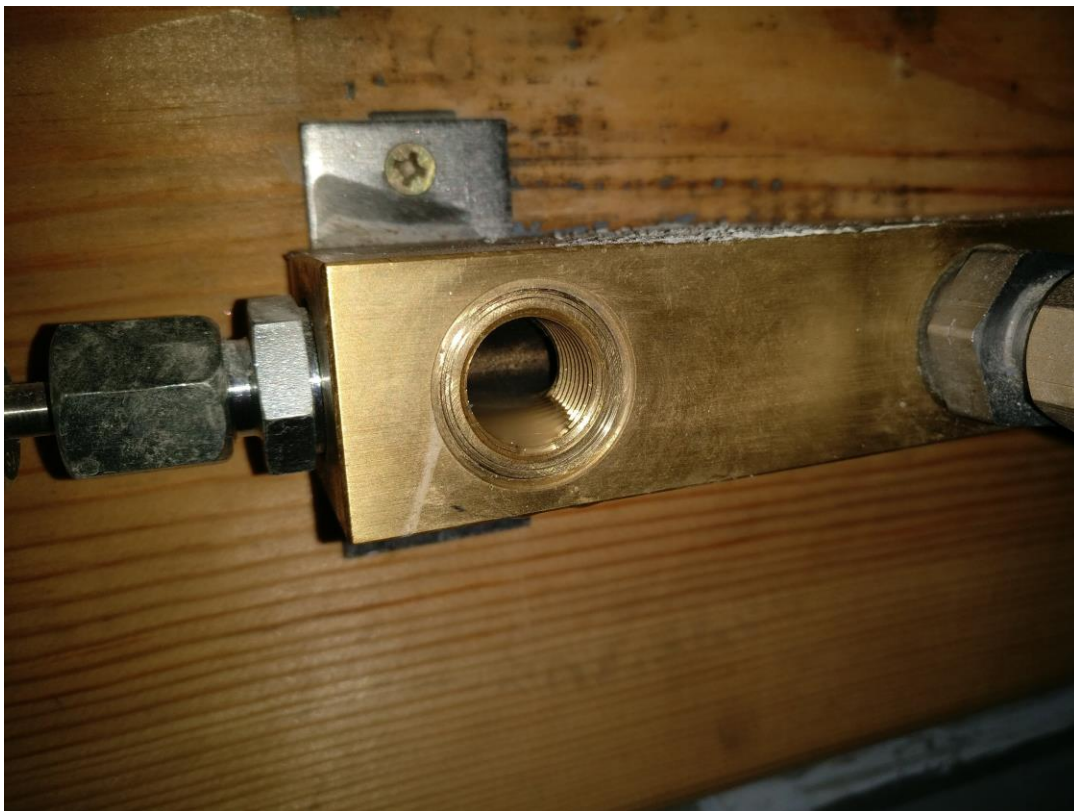
Having run for so long continuously, the filter had become saturated and water and oil from the compressor entered the pipework, manifolds, filling whips and cylinders.

Figure 9 - Photo showing the water in the manifold blocks
